ACCELERATED TESTING OF GEOSYNTHETICS IN TRACKBED USING EUROPE'S LARGEST FULL SCALE RAIL RIG

ABSTRACT

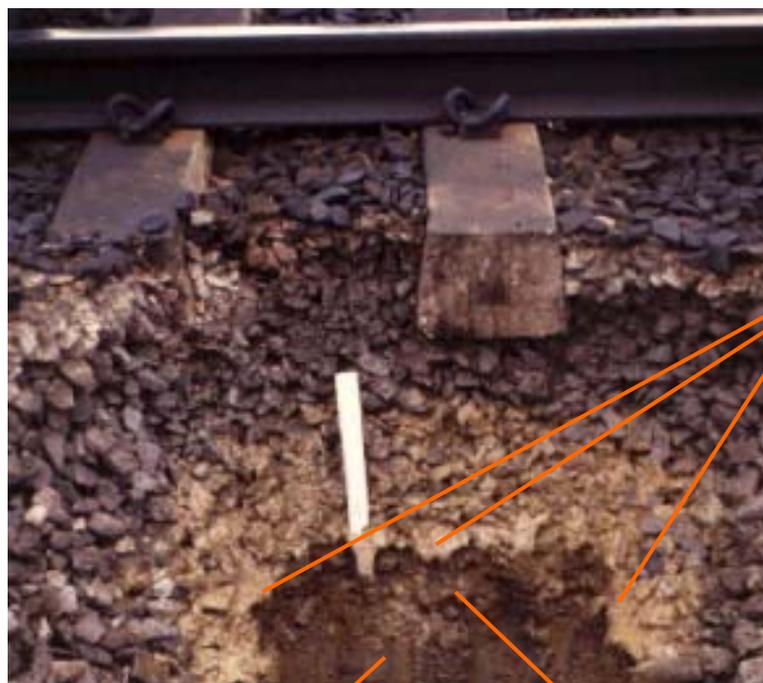
Edge of geotextile

Lower Lias Clay

Failed granular blanket

Figure 1
Failure of a non-woven geotextile after 2 years in a main line track.

When heavy duty textiles first became available it was initially thought that they might replace the traditional sand blanket. However, it was soon realised that no geotextile available at the time had a pore size sufficiently small to prevent the upwards migration of clay or silt sized particles into the ballast, and that all geotextiles were susceptible to abrasion under dynamic loading conditions when placed between coarse granular materials. Figure 1 shows the condition of trackbed two years after treatment with a non-woven geotextile alone. It was concluded that no geotextile could replace a traditional sand blanket.

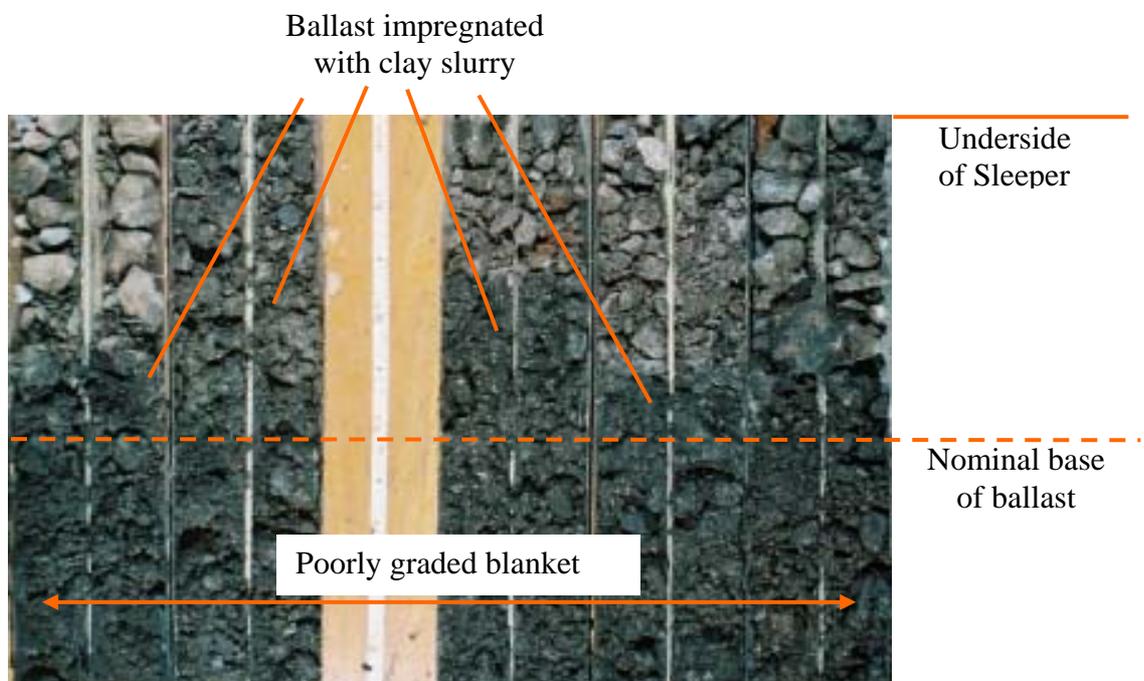
Figure 2 Boreholes taken through trackbed with poor quality blanket.

Typically, a serious subgrade erosion problem would occur where an existing stone blanket layer is poorly graded, i.e. it contains voids which permit the upwards migration of fines. The voids in the stone layer would be too large to hold the fine particles at the exposed upper surface of the clay subgrade in place. The clay particles would become dislodged under the action of dynamic loading in the presence of water, and they would combine with the water to produce a slurry. Under the high pressure generated by traffic loading the slurry is forced upwards, which causes a suction force to develop in the voids after the load has passed. The suction will cause slurry to flow back into the voids, but at a slower rate than it was forced out. Under these conditions there will be a tendency for water to be drawn out of the slurry, resulting in the slurry becoming thinner closer to the clay surface.. Thus, in the presence of a suitable water supply, the process of subgrade erosion is self perpetuating.

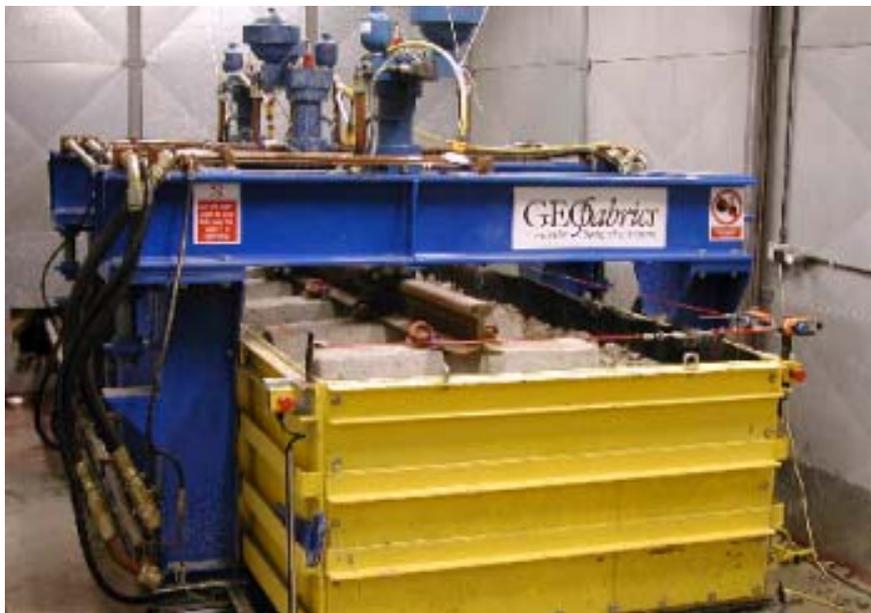
Figure 3 – The Full Scale Rig

The test rig is illustrated in Figure 3. It consists of a half track panel (i.e. single rail supported on seven half length sleepers) seated on a box measuring 4.5m by 1.5m by 1.0m which contained the trackbed, as shown in Figure 4. The load was applied by three computer controlled hydraulic actuators which could replay real rail traffic loadings of up to ten tonnes, ten times per second. The box was watertight and could therefore be used to examine the effects of poor drainage and high water table. Spray head nozzles were located above the ballast, giving the ability to simulate rainfall.

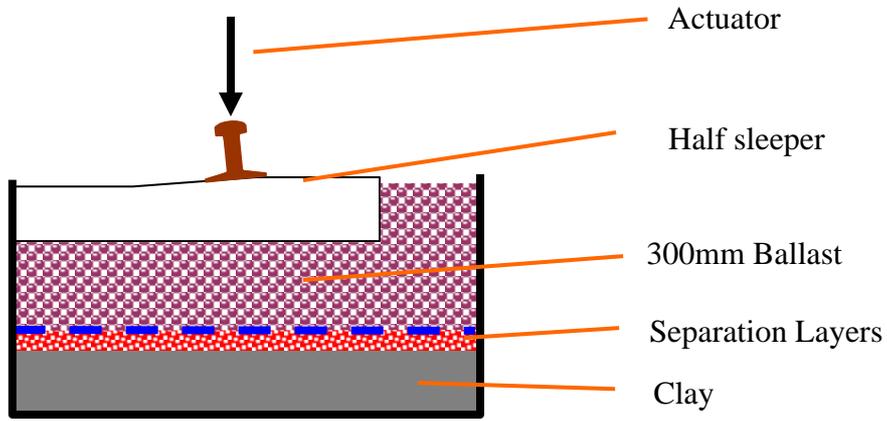
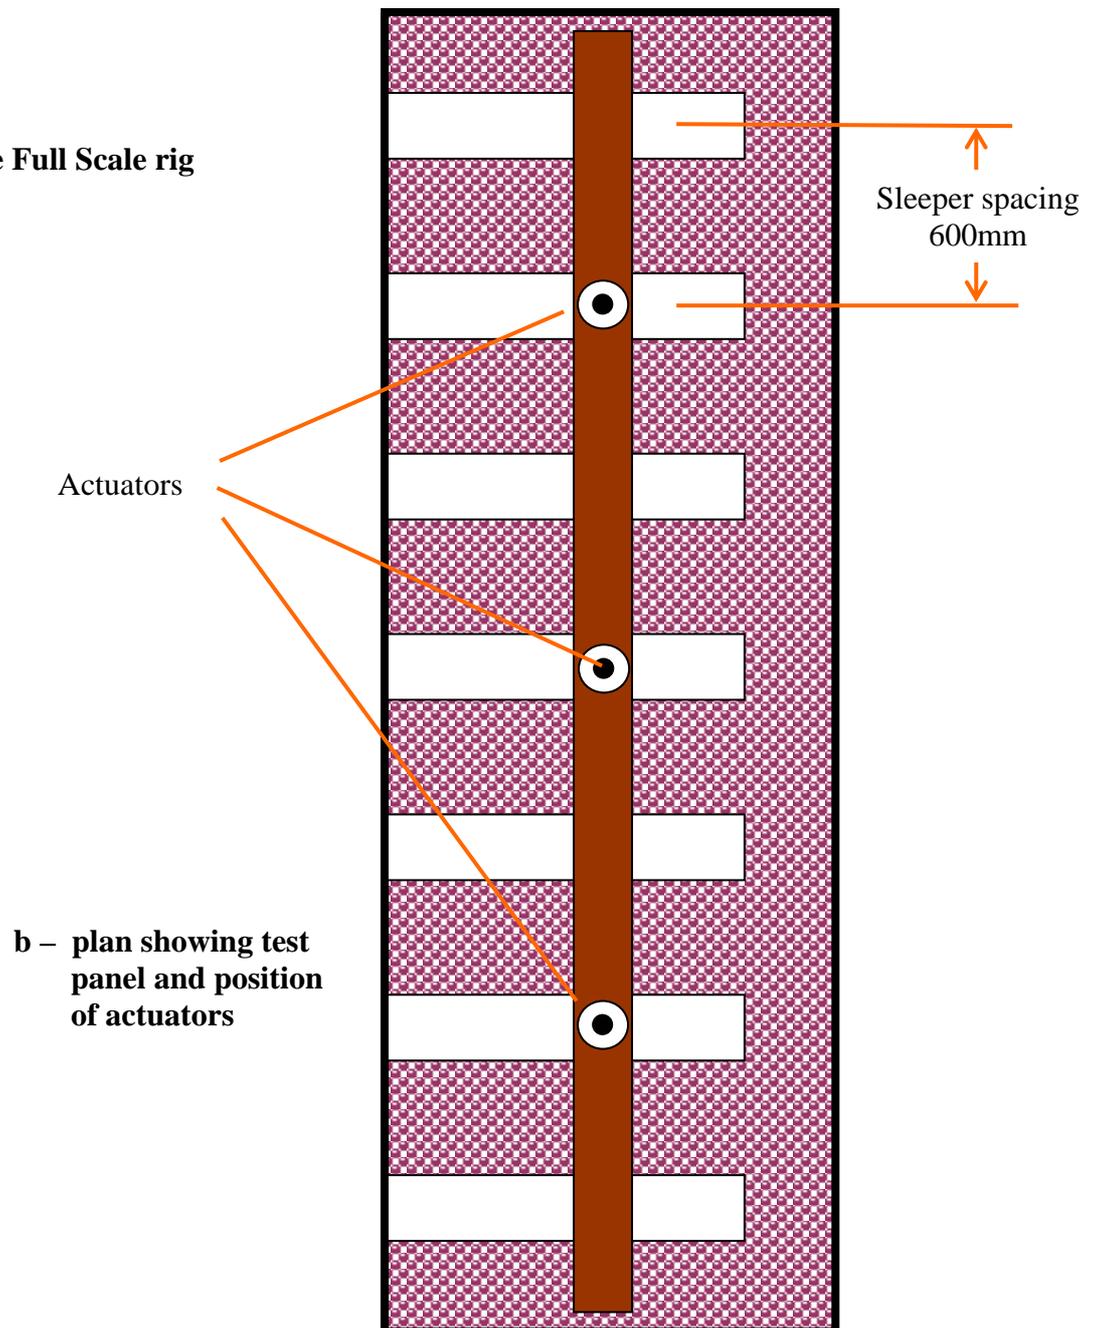
Figure 4 – The Full Scale rig

a – section through box showing a typical test set-up

b – plan showing test panel and position of actuators

The trackbed was founded on a subgrade of 300 mm of reworked London Clay which, in its intact condition, initially had a shear strength above 100kN/m^2 . This is a typical poor subgrade which has been responsible for countless subgrade erosion problems on tracks of South East England throughout the history of the railways. The test bed was prepared to replicate as close as possible a natural London Clay subgrade whose surface had been weathered by over a century of rail traffic, i.e. the upper horizons of clay had softened to a “firm clay” consistency. This was done by placing the clay in lumps and compacting using a Kango hammer, then softening by adding water and forking the top surface to a depth of 50mm, until a soft clay consistency was achieved. In the early tests consolidation occurred, which brought the shear strength of the clay surface to between 25kN/m^2 and 50kN/m^2 . This remained sensibly constant for the remainder of the test period.

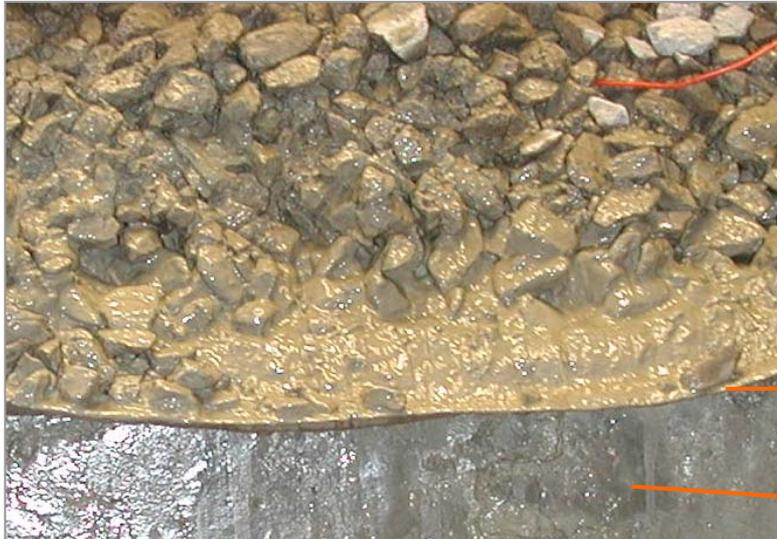
Figure 5 – generation of clay slurry when using a geotextile alone

Non-woven geotextile

Clay subgrade

Figure 5 shows the results of placing a single layer of non-woven geotextile between the clay and ballast. This has been shown in the past to offer little resistance to subgrade erosion, especially under wet conditions. This behaviour was simulated well by the testing; clay slurry had formed rapidly during the test and had risen to a height of 100mm above the geotextile during the course of the test.

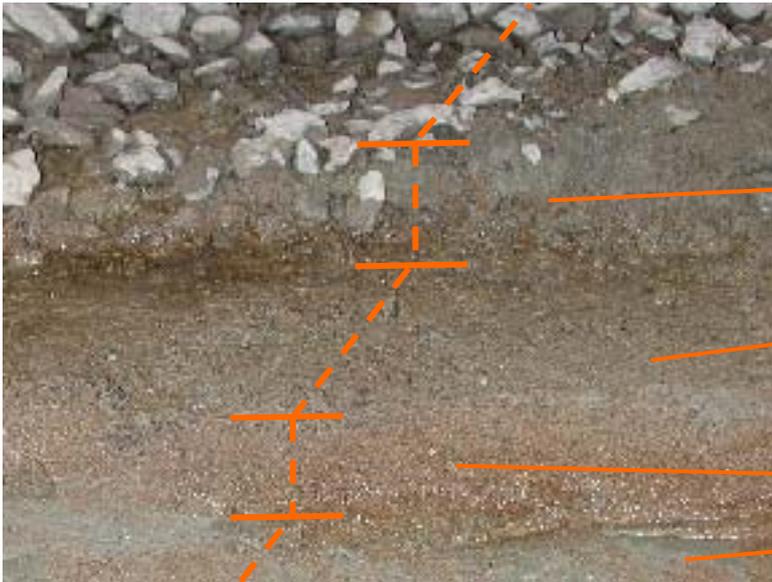
Figure 6 – layers removed to show intermixing at sand/ballast interface when sand used without geotextile separator

Intermixing of ballast and sand, approximately 50mm thick

Sand surface discoloured by ballast fines

50mm thick sand layer

Clay surface

Tests were undertaken after covering the surface of the clay with a layer of blanketing sand to RT/CE/S/033. This is the traditional way to cure a severe subgrade erosion problem. Figure 6 shows intermixing at the sand/ballast interface after testing with no geotextile present. This is typical of sand blankets on sites with poor drainage. Figure 7 shows a section through a sand blanket with a non-woven geotextile separator after testing. The sand formed a good interface with the clay, with no upwards migration of fines. Rolling back the geotextile confirmed that no fines had risen through the sand.

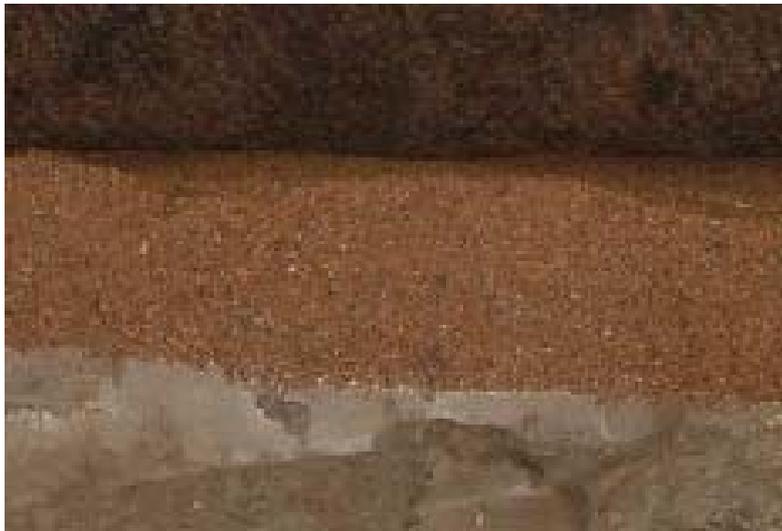
Figure 7 – Section through geotextile/sand blanket, showing its effectiveness as a separator

Geotextile remains undamaged and prevents intermixing at sand/ballast interface

No intermixing at sand/clay interface

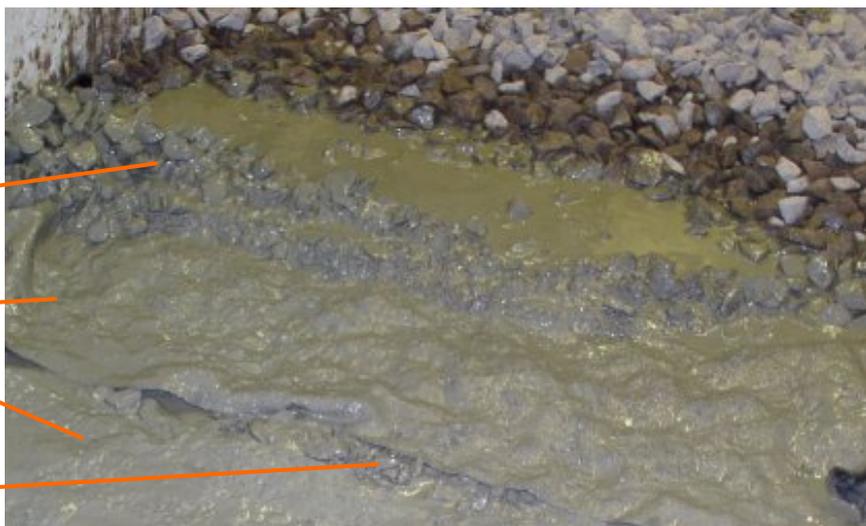
Figure 8 – Uncovering geosynthetics after completion of attrition test.

Slurry has risen 50mm into ballast layer throughout

Non-woven geotextile samples

Stone blanket, voids filled with clay slurry, visible below geotextile

On completion of the test excess water was permitted to drain from the box. The track panel and ballast were then removed, taking care not to cause additional damage to the geotextiles. The slurry had risen approximately 50mm into the ballast above the geotextiles, as shown in Figure 8. From an initial visual inspection there was no obvious difference in the ability of tested geotextiles to hold back the slurry. However, after washing the fines from the geotextiles it became clear that considerable damage had been caused, particularly to Product B.
